# CASE STUDIES ON STRENGTHENING OF CONCRETE AND MASONRY STRUCTURES

ANTONIO NANNI<sup>1</sup>, ANDREA PROTA<sup>2</sup>

Este artículo presenta una serie de estudios de casos relacionados con el fortalecimiento de estructuras de hormigón y mampostería dañadas por el terremoto del 6 de abril de 2009  $M_w 6.3$  que azotó la ciudad italiana de L'Aquila y las localidades circundantes. Después de una breve reseña de los desafíos existentes en los edificios construidos antes de 1972, cuando el primer código de construcción que aborda la construcción sísmica se promulgó en Italia, el documento describe las intervenciones utilizando tecnologías que pueden ser consideradas innovadoras en que no se abordan en la mayoría de la actual Códigos de construcción en todo el mundo. Se describen los siguientes métodos de refuerzo: a) compuestos de polímero reforzado con fibra (FRP) en forma de disposición manual, laminados y espigas obtenidos; B) revestimiento de polímero reforzado con acero (SRP) y espigas; Y, c) la matriz de cemento reforzada con tejido (FRCM). El documento concluye con una descripción de cómo el despliegue de la innovación tiene lugar en los Estados Unidos. Este ejemplo tiene com

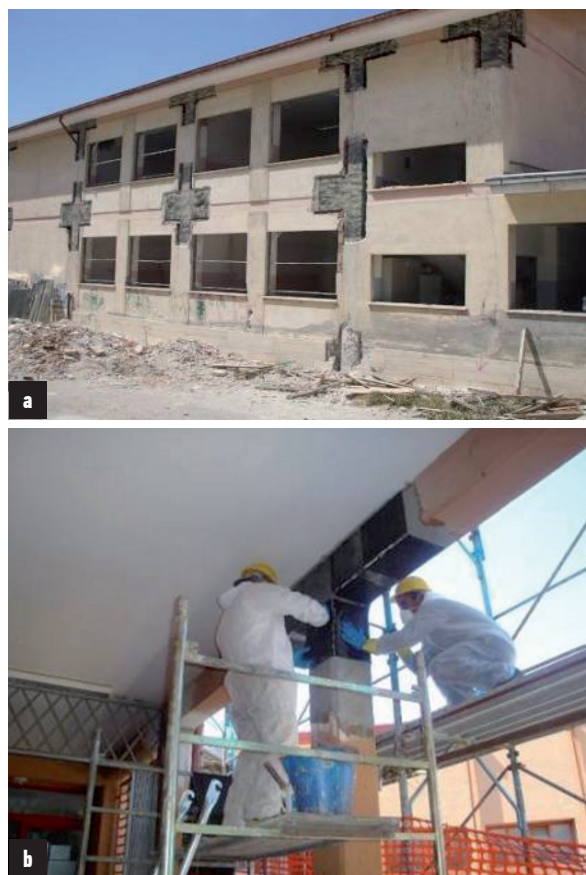
Figure 3. Prep work and strengthening of external joints.

A possible rehabilitation technique adopted for the external joints of the school building shown in figure 3-a consisted of the following after exposure and repair of the concrete surfaces:

Shear strength increase of the joint panel. This was attained by first applying a diagonal sheet of SRP to resist the action of the partition followed by the superposition of a quadri-axial carbon FRP (CFRP) for shear capacity improvement.

1. Ductility increase of the column ends by confinement with continuous uniaxial CFRP wraps with fibers in the horizontal direction (see figure 3-b).
2. Shear strength increase of the beam ends obtained by the application of U-shaped wraps made of uniaxial CFRP sheets.

Many of the external joints of RC framed structures were gravely damaged by the action of the in-fill masonry partitions. In fact, during the oscillatory motion of the frame, a diagonal compression strut would form within the partition resulting on a force applied to the joint that was not accounted for in the design. In most instances joints failure was evidence by a pseudo-horizontal crack.

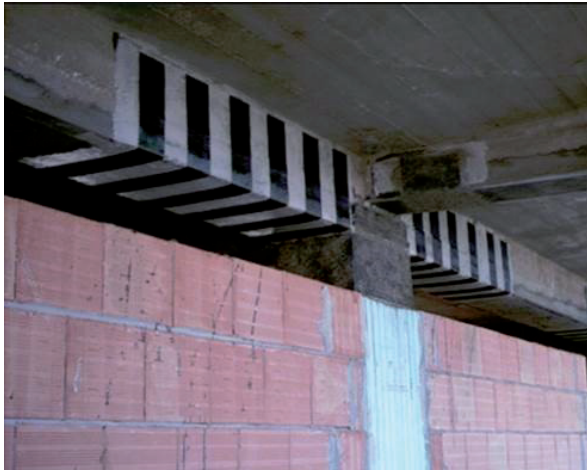
Figure 4. U-shaped CFRP wraps.

Shear strengthening of beams can be accomplished with CFRP U-wraps as shown in figure 4 where they act as external stirrups. Obviously a full-wrap would be more effective by allowing the full anchorage of the fiber sheet. This is however typically not possible due to the presence of the slab that makes a beam cross

section either T or reverse-L shaped (interior or exterior beam).

The issue of U-wrap anchorage is of particularly challenging in the case of negative moment regions where the fiber sheet terminates at the face of the slab since this is the tension zone.

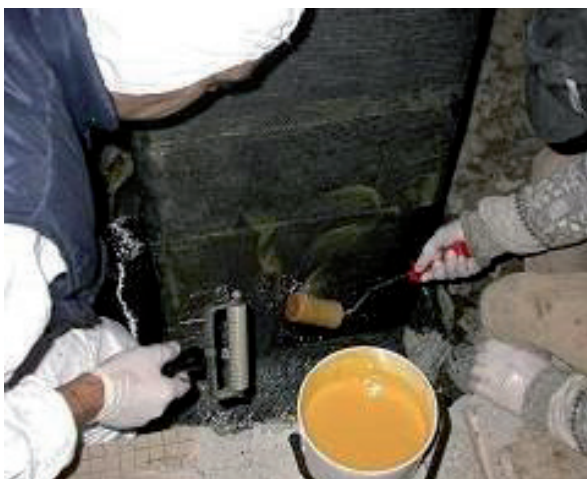
Figure 5. Strengthening of column by full CFRP wrap.

Column strengthening to address shear deficiency is primarily due to concrete poor quality (i.e., low compressive strength) and, even more commonly, improper tie spacing resulting from the application of outdated code provisions that only accounted for gravity loads. Figure 5 shows the case of encasing the base of a square column using a CFRP full wrap with fibers in the direction perpendicular to the column axis.

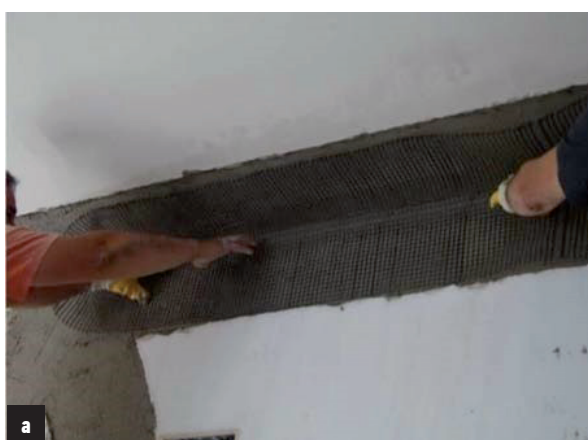
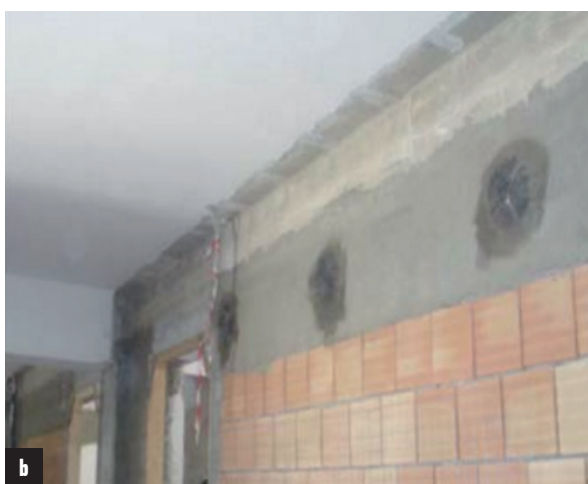
Figure 7. Partition anti-overturning repair with FRCM and SRP spikes.

The cause partition overturning is mainly due to the lack of proper connection to the RC frame (both vertically and horizontally). Thus, a possible repair method is the anchoring of the panel with glass FRCM and SRP spikes. First, the plaster covering the panel perimeter including portions of the concrete frame has to be removed. Second, passing holes are drilled in the partition at regular intervals along the perimeter for the installation of the spikes. Third, the cementitious grout and the alternating glass fabric reinforcement are applied in layers (see figure 7-a). Finally, the still spikes are installed in the pre-drilled holes, the wires fanned out and impregnated with resin (see figure 7-b) so that the proper continuity and two-face anchoring is established.

The use of hollow clay infill panels is a common practice in buildings with reinforced concrete frames. One of the two possible failure modes of these non-structural elements is out-of-plane overturning that is a major concern in building facades due to the possible catastrophic consequences of falling debris.

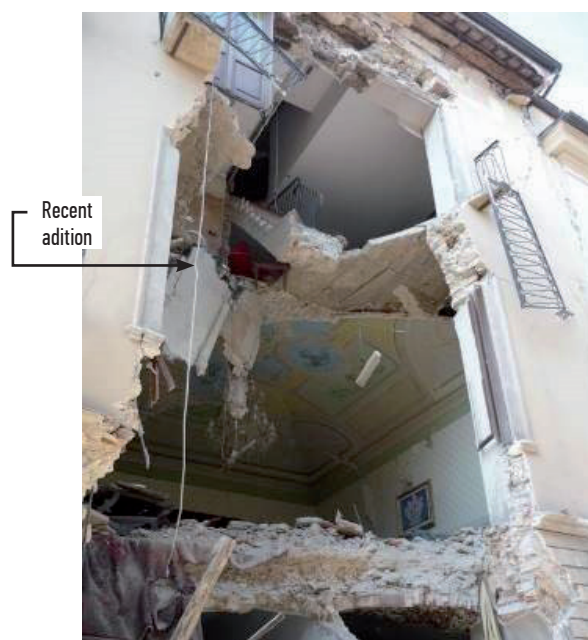
Figure 8. Damage resulting from insertion of concrete stair.

Unreinforced masonry buildings are particularly vulnerable to the effects of lateral loads due to seismic events. This is the result of the typically heavy mass and the lack of continuity among elements (e.g., walls and slabs). Of particular concern are non-engineered structures made of low quality materials that have also undergone alterations due to the needs of modern living. This is the case of the building shown in figure 8 where the addition of a reinforced concrete stair on the second floor was responsible for significant damage and the collapse of the façade due to its stiffness and the consequent modification of the load path.

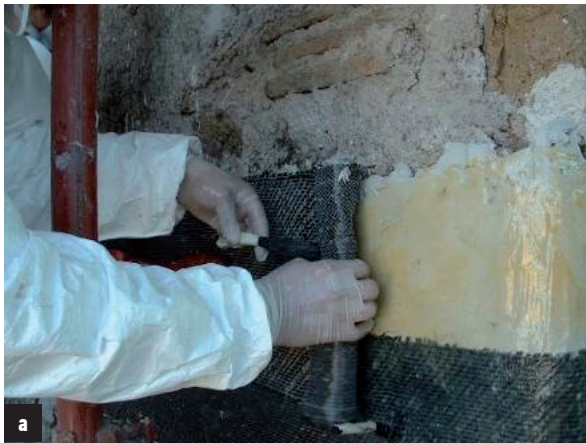
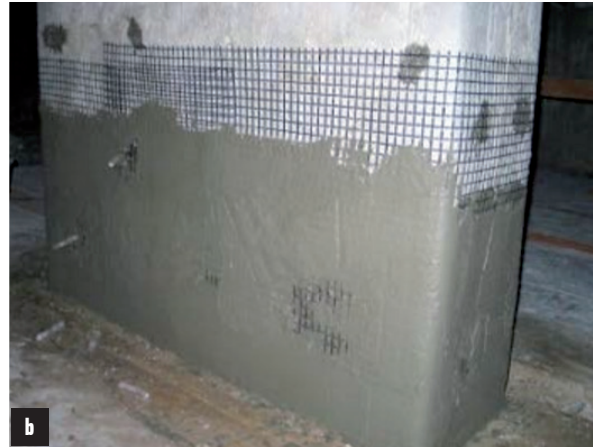
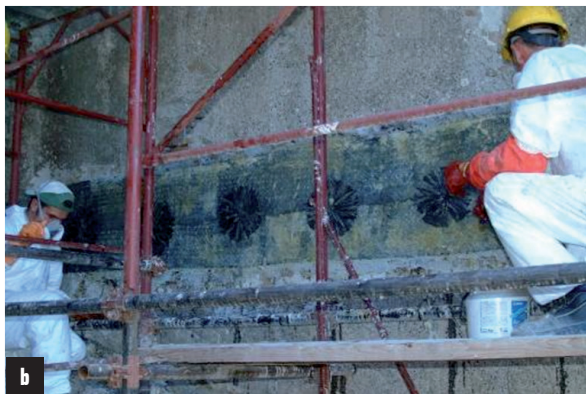
**Figure 9.** Wrapping with CFRP plies anchored with CFRP spikes.

The wrapping of masonry buildings at floor and roof locations can be achieved with FRP plies applied by wet lay-up (only rounding the corners of the building) anchored by FRP spikes as shown in figure 9-a and -b. The preparation of the substrate is of particular importance in order to provide a surface as flat as possible. Re-entrant corners should be avoided.

FRP retrofit measures can provide proper connection between walls as well as between walls and slabs preventing out-of-plane failures thus mobilizing in-plane strength of the walls under seismic actions. In the case of unreinforced masonry buildings, the optimal solution would be embracing the entire perimeter of the building with the selected FRP system.

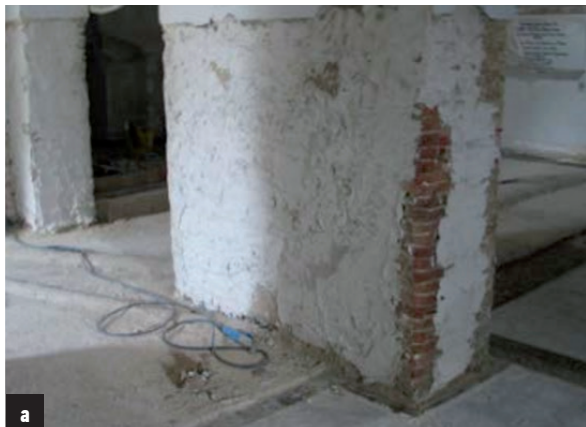
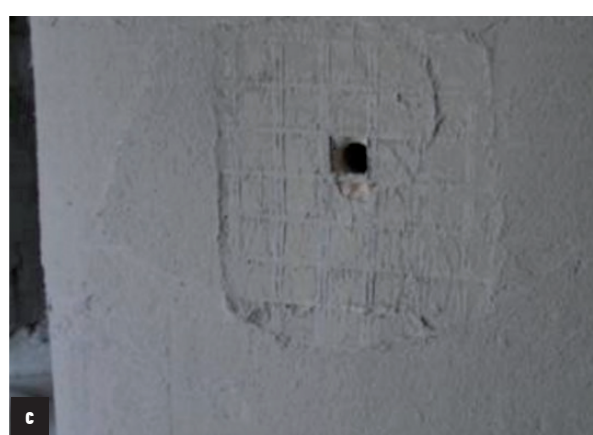
**Figure 10.** Application of mortar followed by carbon fabric and spikes.

Strengthening of masonry structures to enhance in-plane performance is as critical and needs to be addressed as part of a global intervention. figure 10-a shows the initial phase of surface preparation for the installation of a glass FRCM system. After removal of the plaster, the first layer of mortar is applied followed by the application of the glass fabric reinforcement. As noted in figure 10-b, the fabric is lapped to ensure stress transfer. Finally, as shown in figure 10-c, passing holes are drilled for the insertion of Glass FRP spikes.
